# Manhole Inspection Summary

Manhole # S33II2004MH

Insp Date: **12/18/06 11:16 AM**

**Location** Address: **6300 BOXWOOD RD**

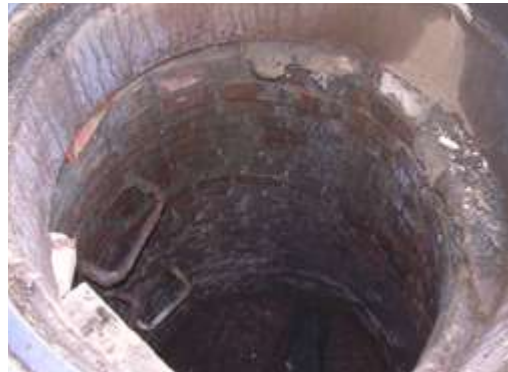
Defect

Frame offset. Adjustment deterioration, loose brick and infiltration. Corbel and Barrel infiltration - other side.
